MARINE CASUALTY REPORT

MOBILE OFFSHORE DRILLING UNIT (MODU) OCEAN RANGER, O.N. 615641, CAPSIZING AND SINKING IN THE ATLANTIC OCEAN, ON 15 FEBRUARY 1982 WITH MULTIPLE LOSS OF LIFE

REPORT NO. USCG 16732/0001 HQS 82

**REPORT OF THE U.S. COAST GUARD
MARINE BOARD OF INVESTIGATION CONCERNING
THE MODU OCEAN RANGER, O.N. 615641;
CAPSIZING AND SINKING IN THE ATLANTIC OCEAN
ON 15 FEBRUARY 1982 WITH MULTIPLE LOSS OF LIFE**

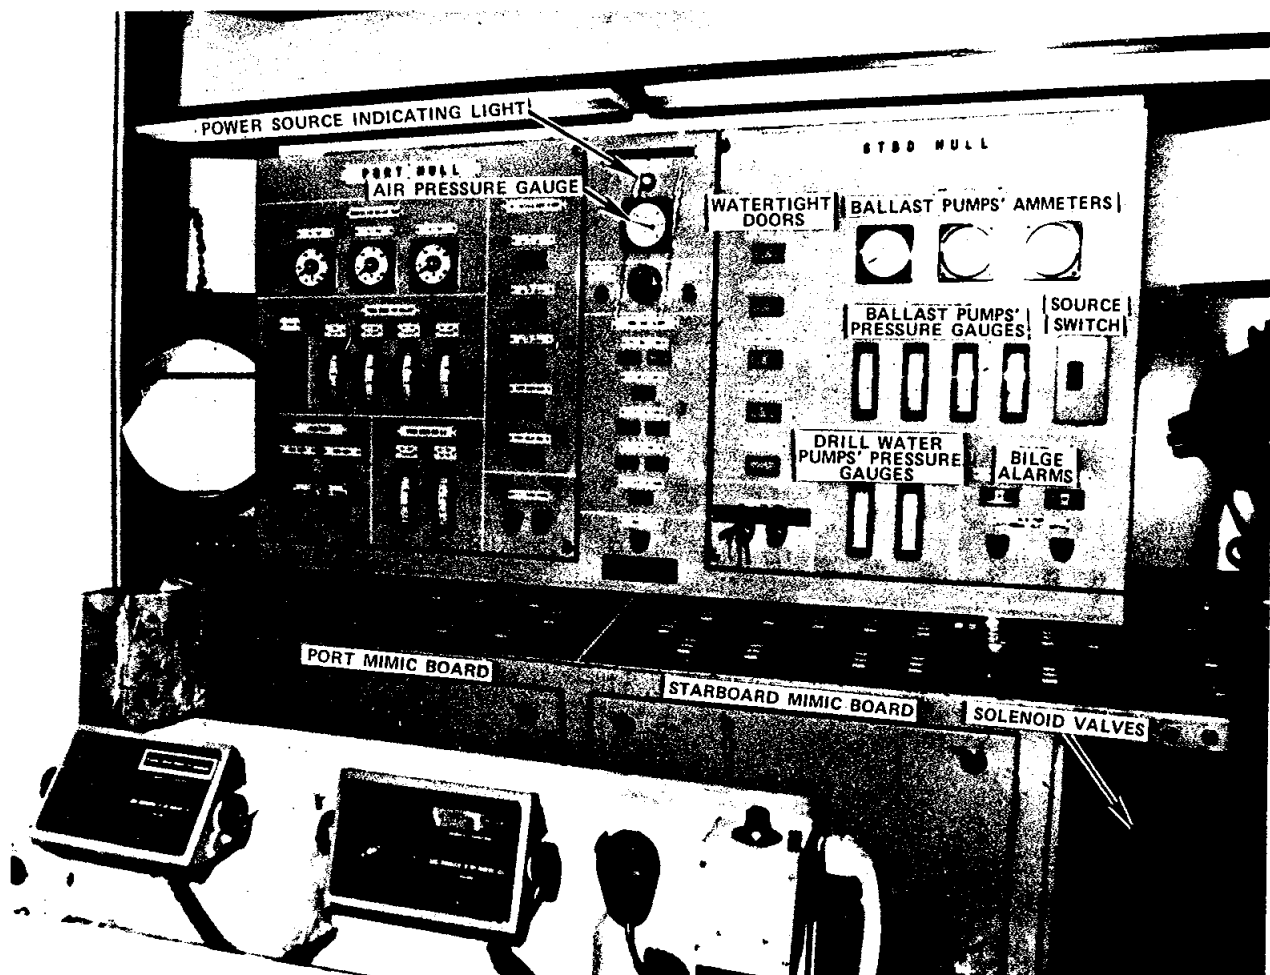
The ballast control room operator was able to view sea conditions and the vessels draft through four portlights¹ installed in the column. The installed portlights were manufactured to standards established by the Japanese Standards Association. Each portlight was permanently installed in the column and could not be opened. Each portlight assembly was made tight by the installation of through bolts around the periphery of the portlight. Post casualty video tapes confirmed that all deadlights had been closed from the inside.² Underwater surveys confirmed that the two portlights located on the portside of the ballast control room were broken (Please see Figure 9).

b. Physical examination confirmed the accuracy of prior video tapes in that two of the four portlights were in fact broken. (Please see figure 9 for the location of the broken portlights.)
